DEPARTMENT OF TRANSPORTATION

Contract #: 04-0120F4Cty: SF/ALA Rte: 80 PM: 13.2/13.9File #: 69.28**WELDING INSPECTION REPORT****Resident Engineer:**Pursell, Gary**Address:** 333 Burma Road**City:** Oakland, CA 94607**Report No:** WIR-015002**Date Inspected:** 06-Jun-2010**Project Name:** SAS Superstructure**OSM Arrival Time:** 700**Prime Contractor:** American Bridge/Fluor Enterprises, a JV**OSM Departure Time:** 1900**Contractor:** Zhenhua Port Machinery Company, Ltd (ZPMC), Changxing Island **Location:** Shanghai, China**CWI Name:** Xu Tao**CWI Present:** Yes No**Inspected CWI report:** Yes No N/A**Rod Oven in Use:** Yes No N/A**Electrode to specification:** Yes No N/A**Weld Procedures Followed:** Yes No N/A**Qualified Welders:** Yes No N/A**Verified Joint Fit-up:** Yes No N/A**Approved Drawings:** Yes No N/A**Approved WPS:** Yes No N/A**Delayed / Cancelled:** Yes No N/A**Bridge No:** 34-0006**Component:** OBG COMPONENT**Summary of Items Observed:**

WELDING INSPECTION REPORT

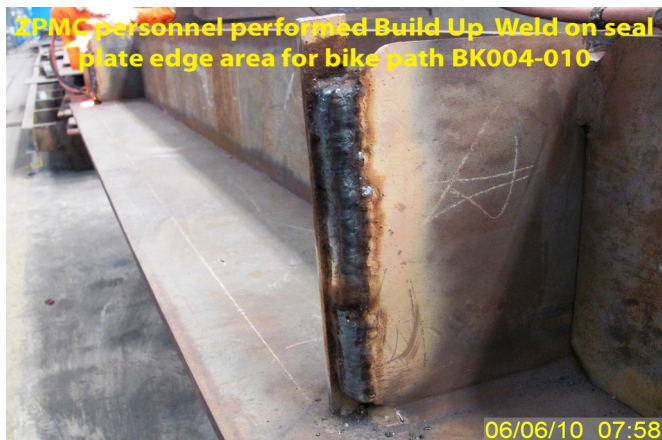
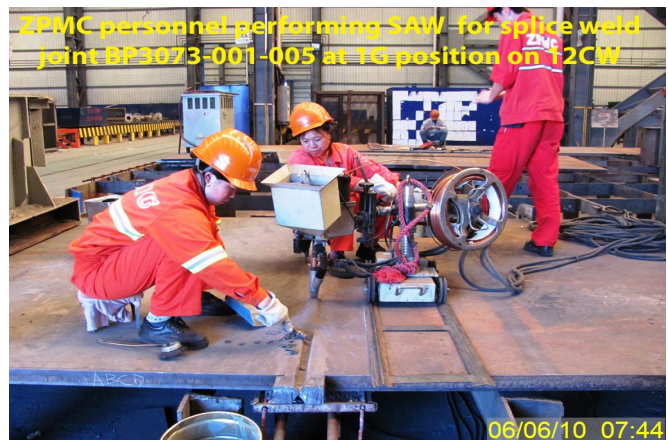
Unless otherwise noted, all work observed on this date appeared to generally comply with applicable contract documents.
